Burning Ground Remediation

Soil excavation and UXO search and clear operations

2023

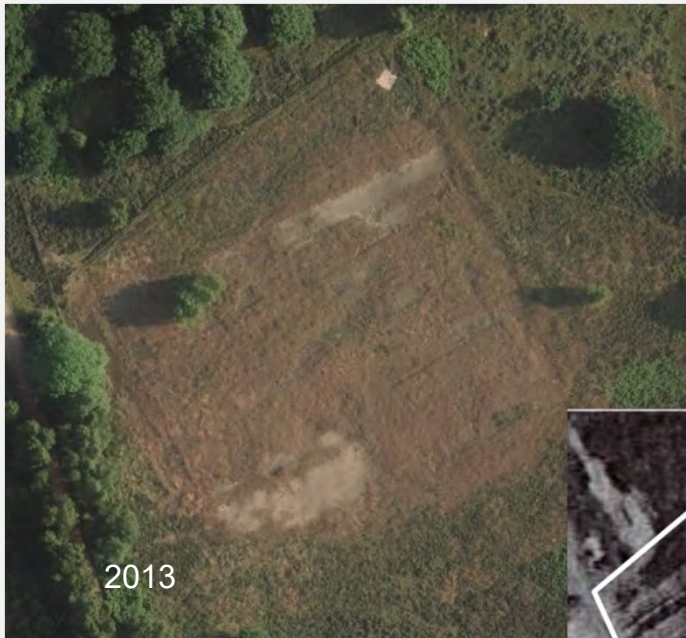
Conceptual Site Model (for environmental impact)

- Groundwater at the site is present within the main aquifer at depths of 18 to 21m below ground level – not impacted and incomplete pathway
- Soil comprises made ground varying in thickness 1-2m overlying natural sands

- Lead (up to 13000mg/kg) and Zinc (up to 440000mg/kg) impact within the made ground requiring remediation
- Receptors: site users, cattle and ecology

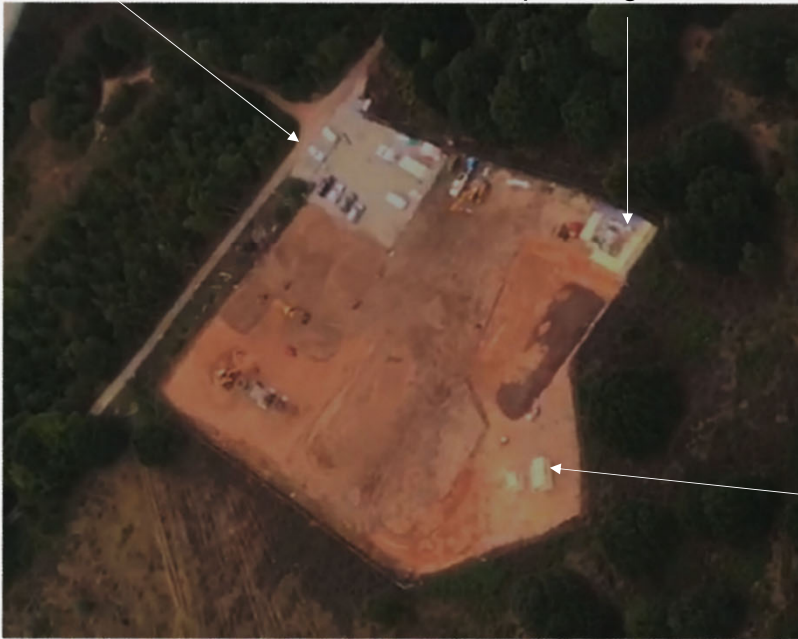
Compound Area

UXO demolition area & scrap storage

- Vegetation scrape completed across the site.
- Excavation of impacted soil at the site compound area
- UXO storage area and set up of the UXO demolition area.

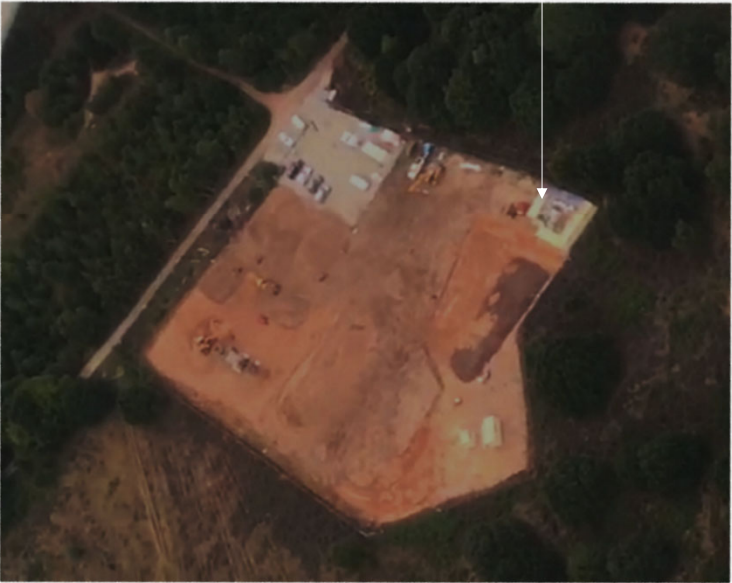
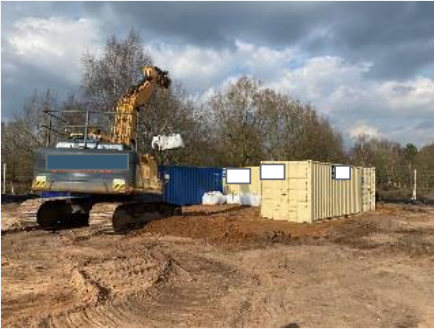
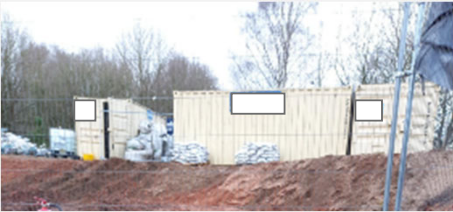
Setup of UXO demolition area

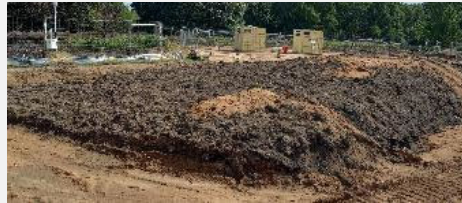
- Green waste
- Vegetation scrape
- Excavated soils
- Scrap metal
- UXO

- Free of explosive certificate => For this the works need to meet the definition for ALARP (as low as reasonably practicable). It is required that the material has been subject to the necessary steps to remove explosives to ALARP levels

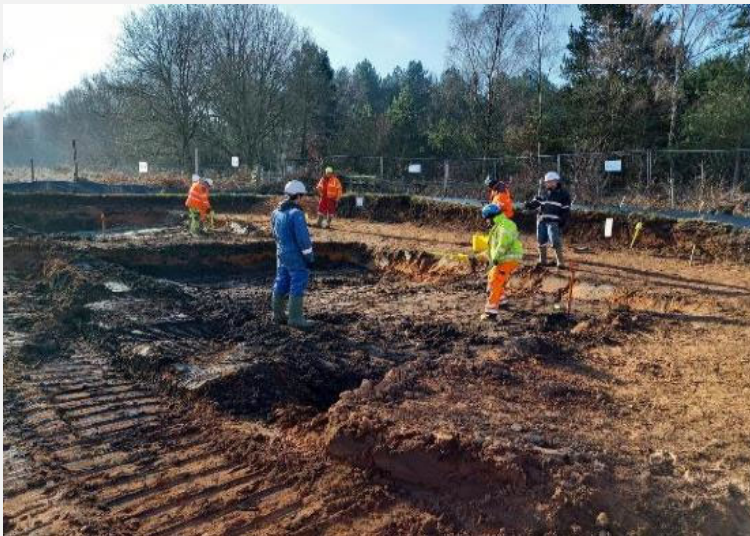
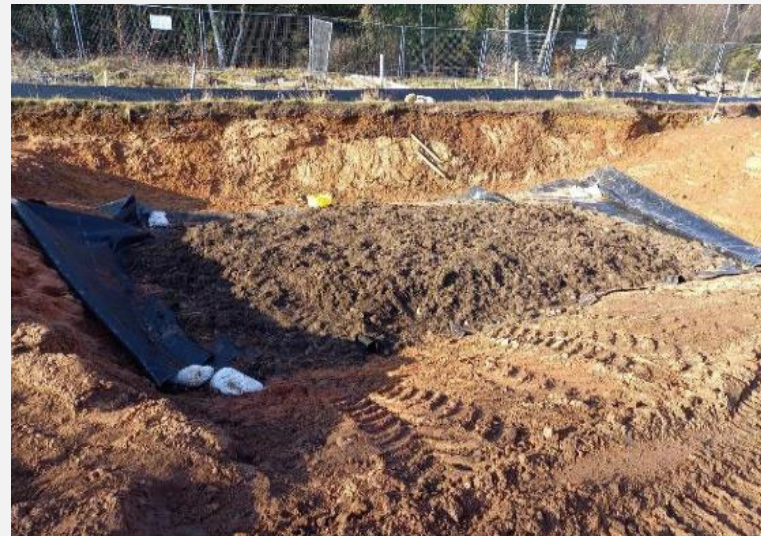
UXO Search and Clear - pads

Search and clear pads: applied throughout the works at different set up to achieved the highest productivity possible

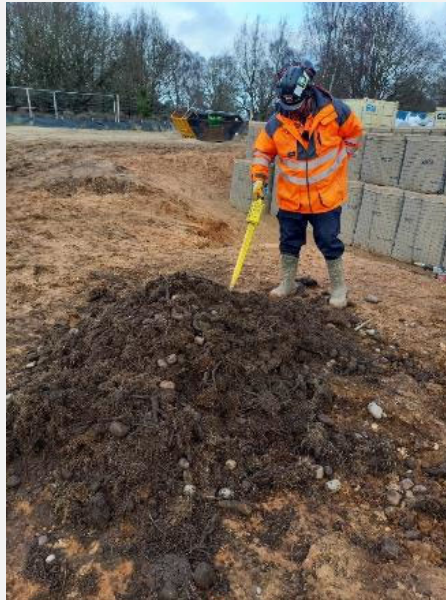
Schonstedt GA-72Cd - Magnetometer

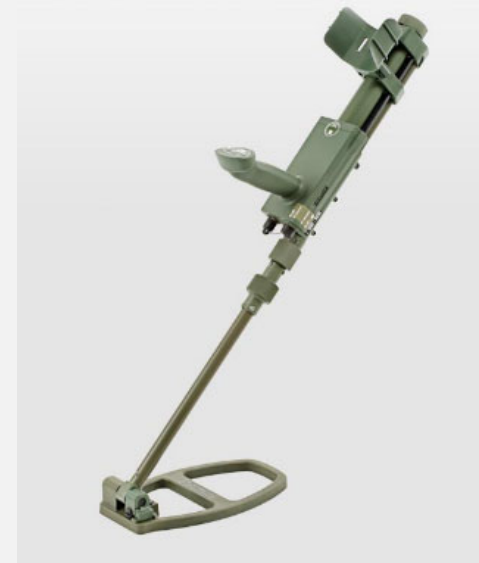
Vallon VMH3CS – metal detector

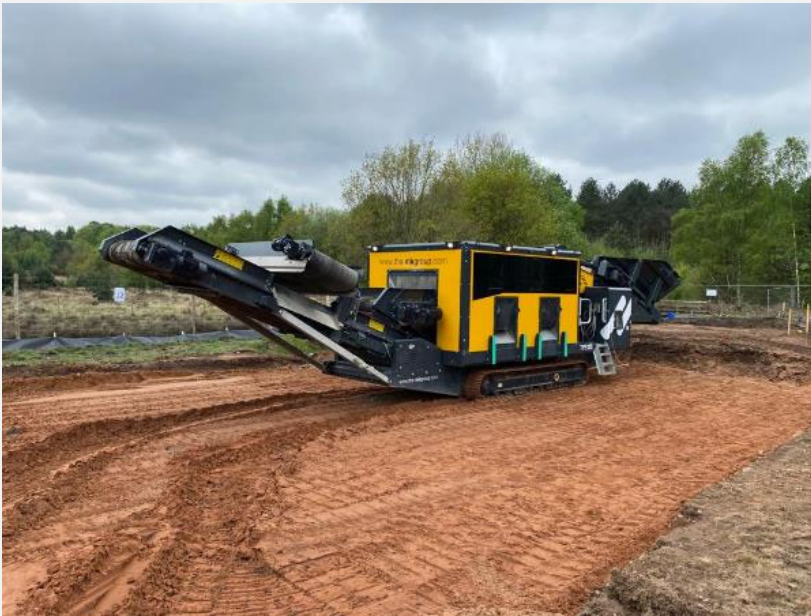
UXO Search and Clear – single picking station

- Aiming to expedite the production of cleared material to be removed from the site and maintain the highest level of search and clear
- The approach comprised the material undergoing two-step search and clear process:
 - 1) Ferrous UXO item detection completed at the search and clear pad with Vallon VMH3CS.
 - 2) Non-ferrous UXO item detection completed by hand picking from the conveyor belt within the picking station.

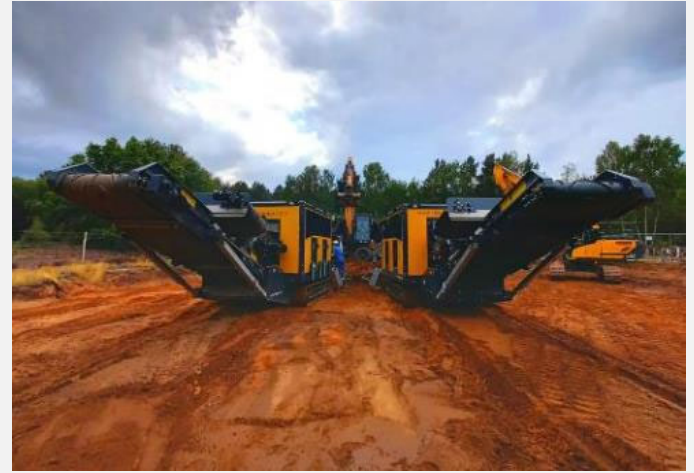
UXO Search and Clear – second picking station

- A second picking station was later mobilised to site on in order to increase productivity of the search and clear process given the challenges posed to the process by the high scrap density and variable nature of the material
- The approach comprised the material undergoing two-step search and clear process:
 - 1) Ferrous UXO item detection completed at the search and clear pad with Vallon VMH3CS.
 - 2) Non-ferrous UXO item detection completed by hand picking from the conveyor belt within the picking stations.

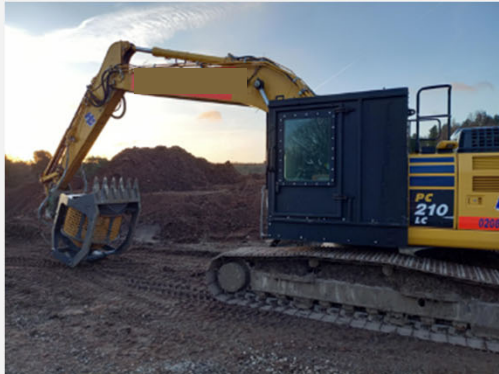
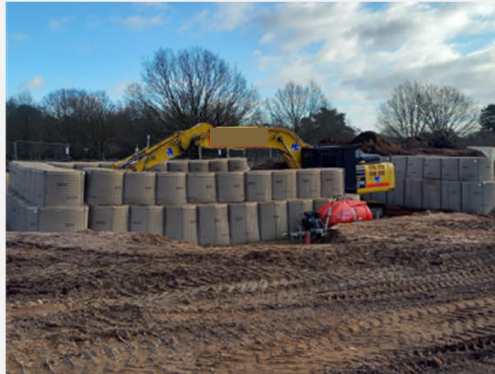
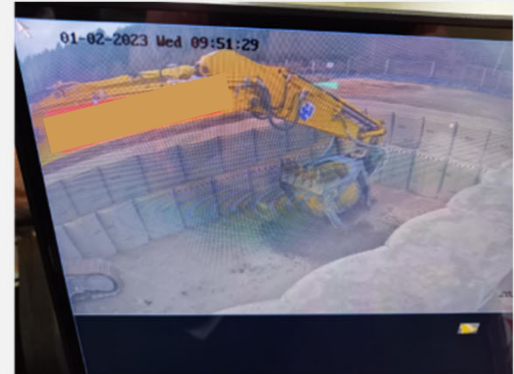
UXO Search and Clear – Armoured sifting operations

- HESCO bastion installed in a retaining wall formation around the working area.
- Sifting bucket (40mm mesh) was fitted to the armoured excavator to process the vegetation scrape material, which was successfully completed.

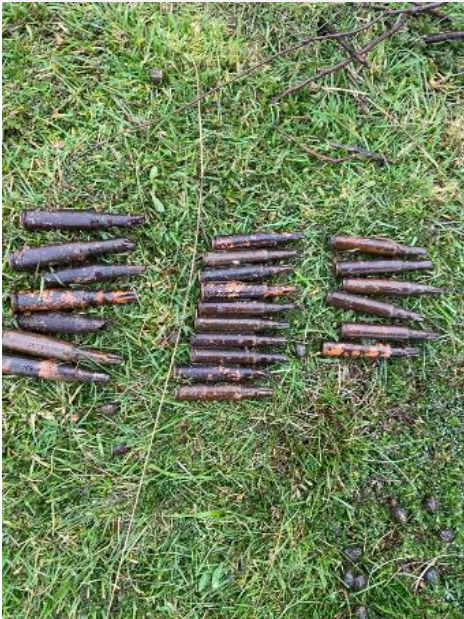
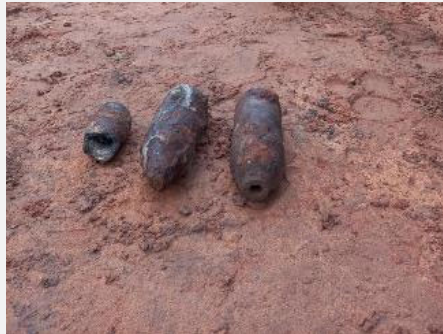
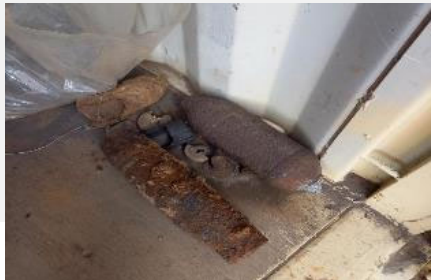
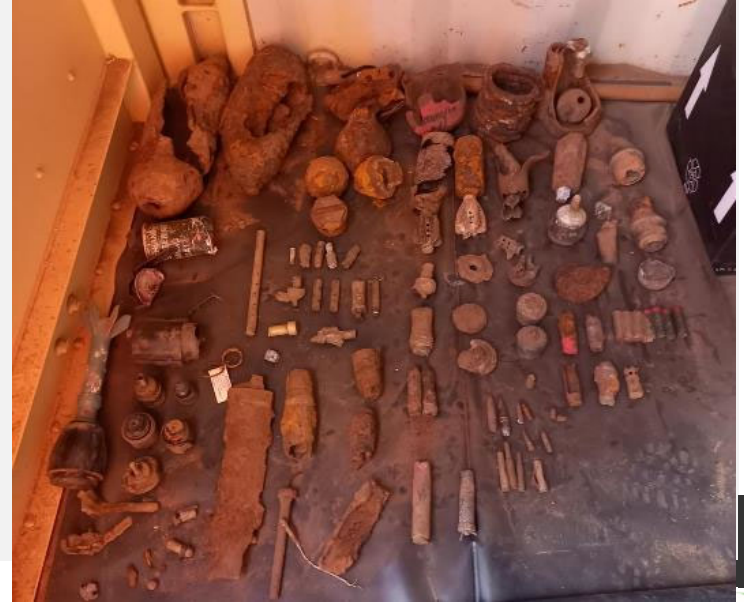
UXO Findings

Findings include: smoke grenades, bullets, grenades, projectiles, launchers, detonators, rounds, 60mm casings, mortars, fuzes

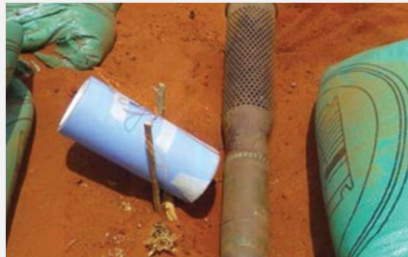
Thermite flare:
Burns with a jetting flame
> 2000°C

Note: photo for illustration only not from site
